Dusts and Residues from Machining and Incinerating Graphite/Epoxy Composites
A Preliminary Study

EPA-600/2-79-196
November 1979

A Preliminary Study

Jack Wagman, Henry R. Berger, John L. Miller, and William D. Conner

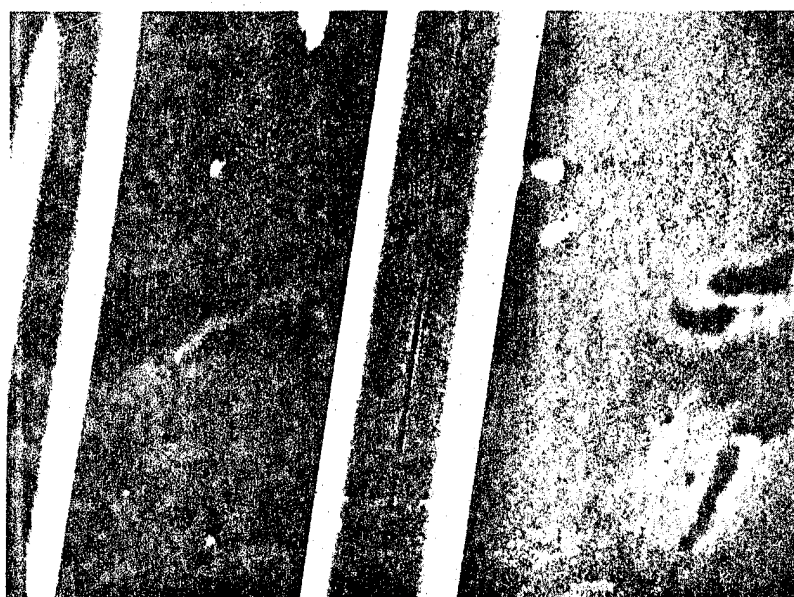
Fig. 1 SEM micrographs of carbon fiber samples:
(a) Panex 1/4 CF (Stackpole); (b) Magnamite
AS3 (Hercules).

Scanning electron micrographs of typical carbon fiber production samples are shown in Figure 1. The fibers appear to be smooth circular cylinders with diameters varying from about 5 to 8 μm , though the actual cross-sectional morphology of different samples vary and include circular, elliptical and dogbone shapes. Some manufacturers expose fiber surfaces to a roughing etch to improve interlaminar shear strength in the composite. Also, a sizing or coating of resin is often added to enhance the bonding capability of the fibers in the composite medium.

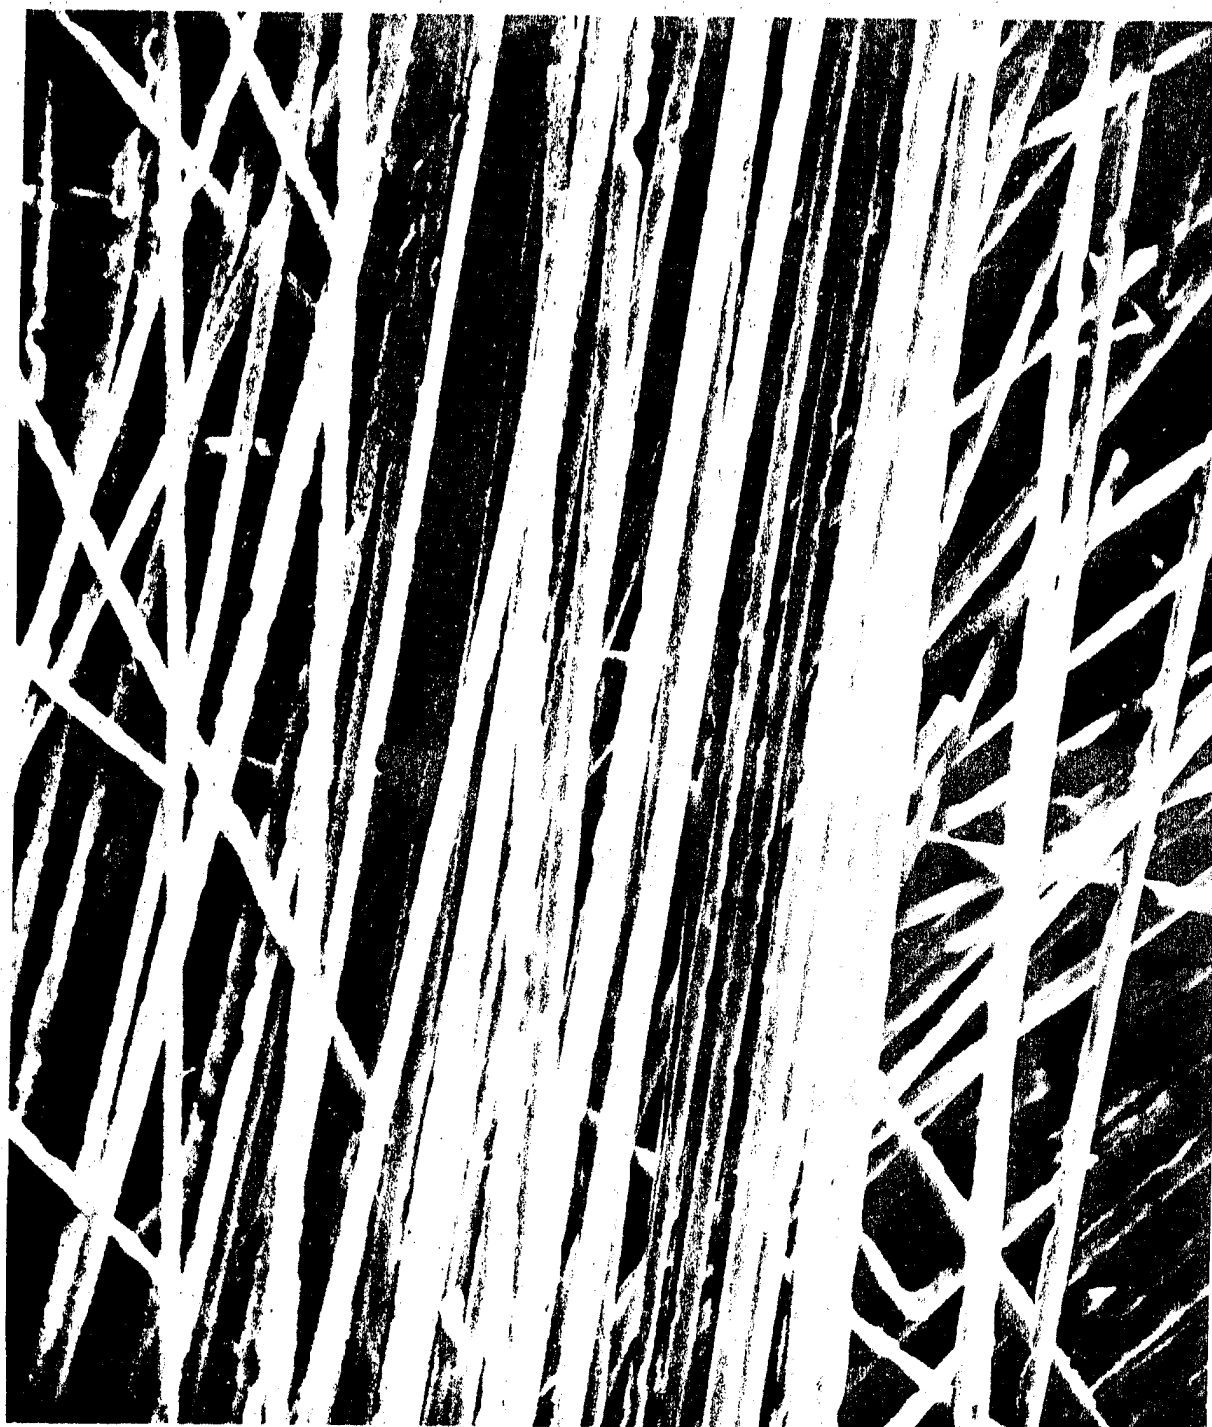
Fig. 5 SEM micrograph of carbon fibers [Thornel 300 (Union Carbide)] after exposure for 3.5 minutes at 1000°C.

Exposure of raw carbon fiber samples to temperatures of 200° to 220° C for 30 to 60 minutes caused little or no damage. As shown in Figure 3, there were no discernible changes in the appearance of the fibers when observed in the SEM. At a temperature of 1000° C, however, the fibers showed definite signs of degradation after a short period. Dimples or pits in the fibers appeared after 1 minute (Figure 4) and were deep and numerous after 3 1/2 minutes (Figure 5). A general thinning of the fibers even in undimpled portions was also noted.

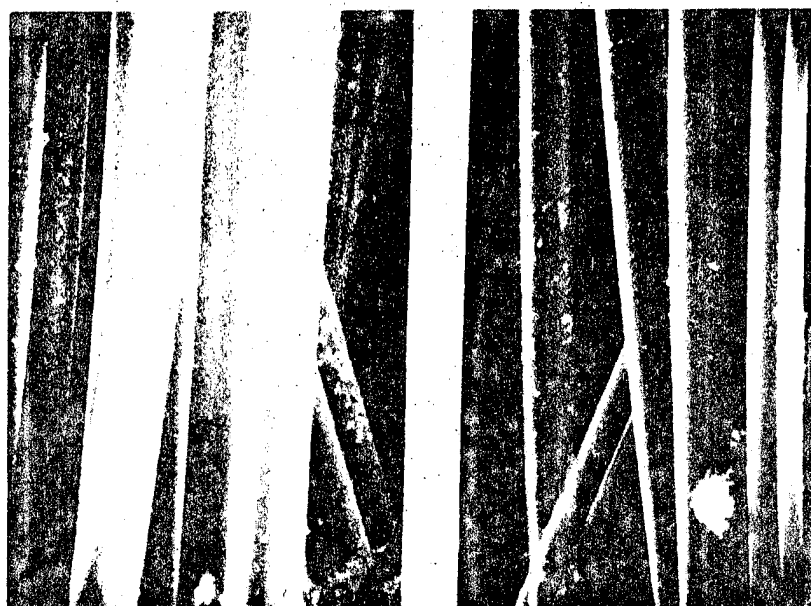
Fig. 6 Micrographs of residues after exposure of graphite/epoxy composite sample [Fortafil 5 (Great Lakes Carbon)] for 5 minutes at 1000°C: (a) SEM micrograph; (b) optical micrograph.

When samples of carbon fiber composite in epoxy resin matrices were subjected to elevated temperatures, the epoxy matrix material was incinerated first, leaving the fibers virtually intact at temperatures of 300 - 600° C and delaying the degradation of fibers at 1000° C. Examination of composite samples after 5 minutes at 1000° C showed some charred remains of the epoxy matrix adhering to apparently unaffected fibers (Figure 6), as well as some fiber clusters completely free of epoxy residue with little, if any, significant damage to the fibers (Figure 7).

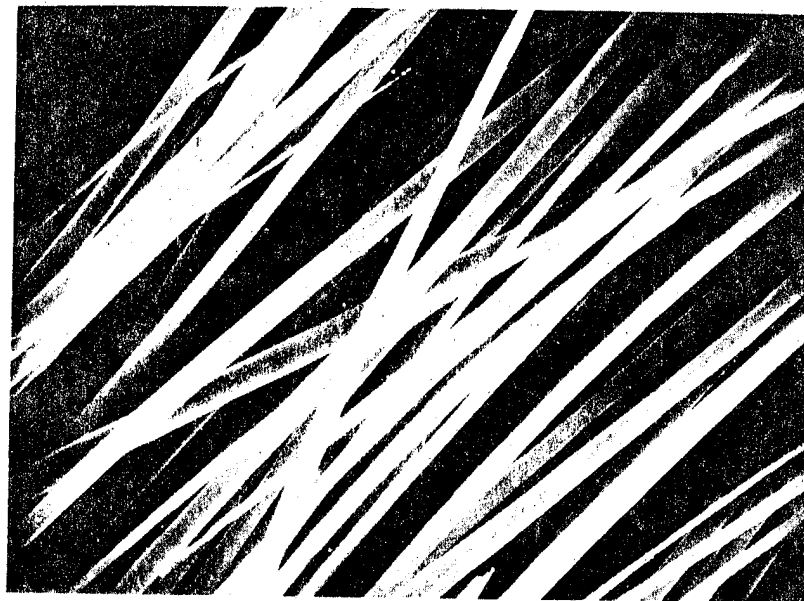
Fig. 8 Woven cloth sample [Panex PWB-6 (Stackpole)] after exposure for 23 minutes at 1000°C: SEM micrographs at two different magnifications.

Another type of carbon fiber product subjected to incineration was a woven cloth (Panex PWB-6 manufactured by Stackpole) designed for high heat resistance. After exposure for 23 minutes at 1000° C, the cloth fibers were still in remarkably good condition (Figure 8) though showing very definite signs of damage including thinning and pitting.

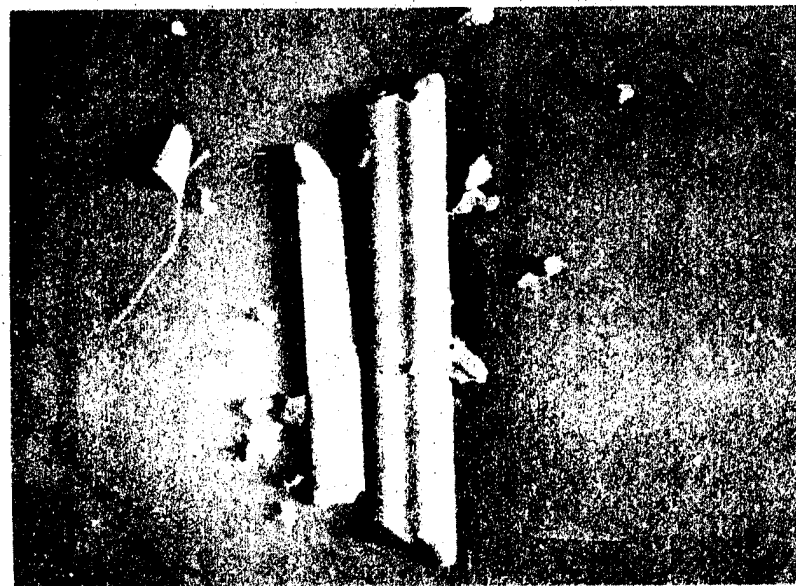
Fig. 9 SEM micrographs of dust particles from drilling a sample of graphite/epoxy composite: (a) large particle containing fibers still bound in resin; (b) free fibers.

Microscopic examination of dust generated by drilling a sample of composite (Fortafil 3U manufactured by Great Lakes Carbon) showed (Figure 9) the presence of free fibers in lengths mainly from about 50 to 100 μ m in addition to particles of epoxy debris.
